CHICOPEE FALLS  
LOCAL PROTECTION PROJECT  
SPECIAL STUDY  
SLOPE PROTECTION IN PROJECT LIMITS

PREPARED FOR  
U. S. ARMY ENGINEER DIVISION  
NEW ENGLAND

OCTOBER, 1962

GREEN ENGINEERING AFFILIATES, INC.  
BOSTON MASSACHUSETTS

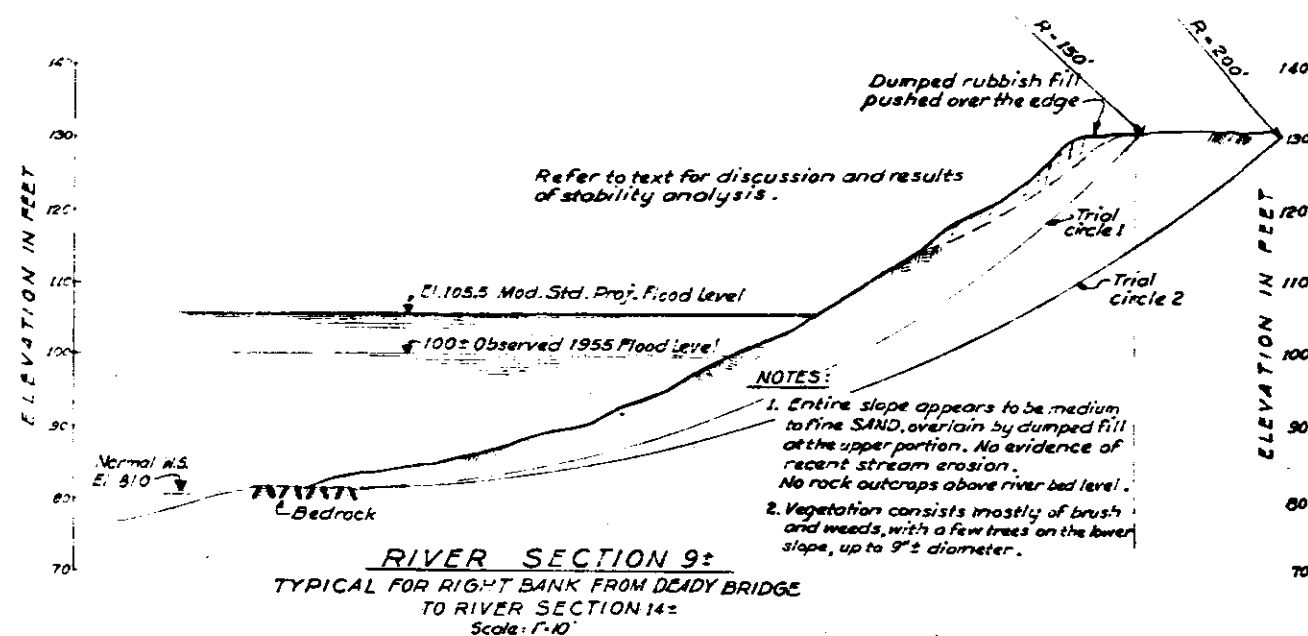
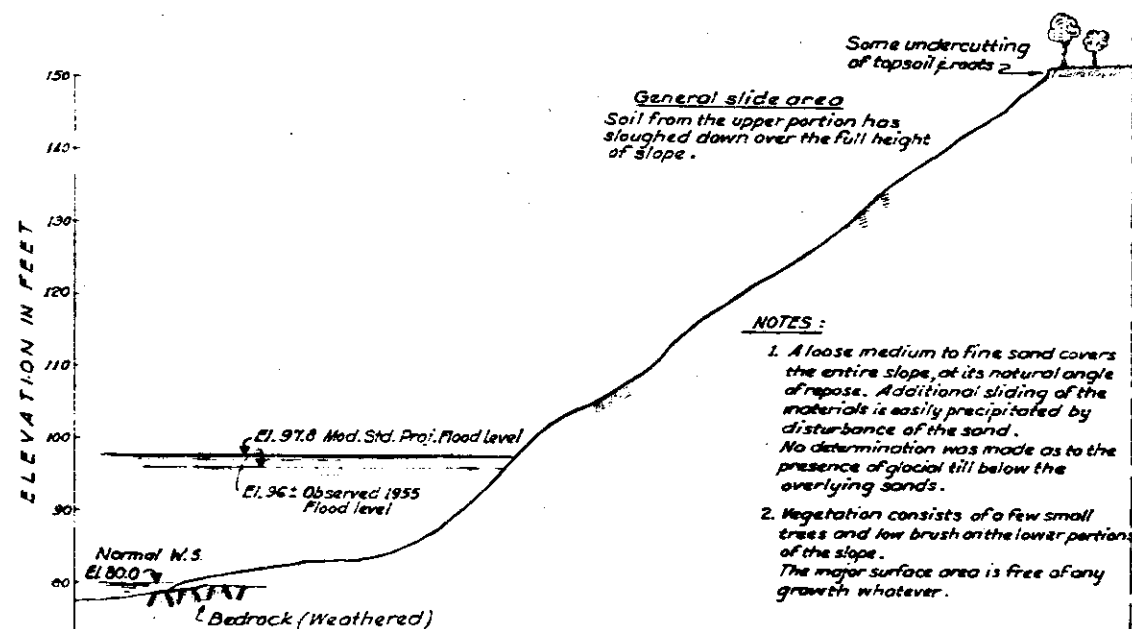
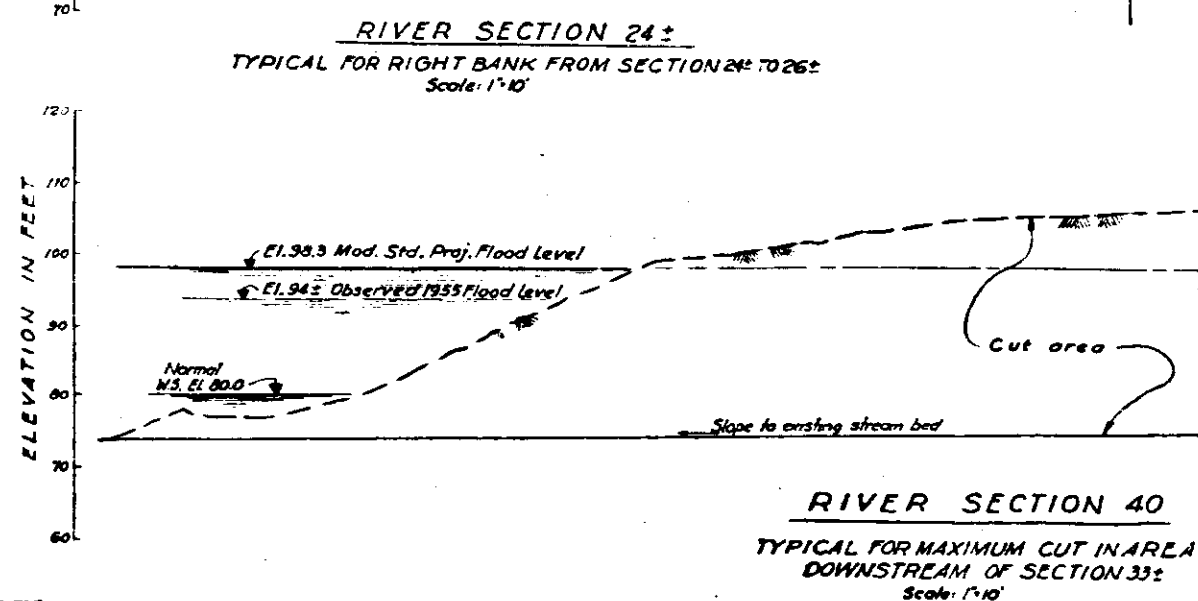
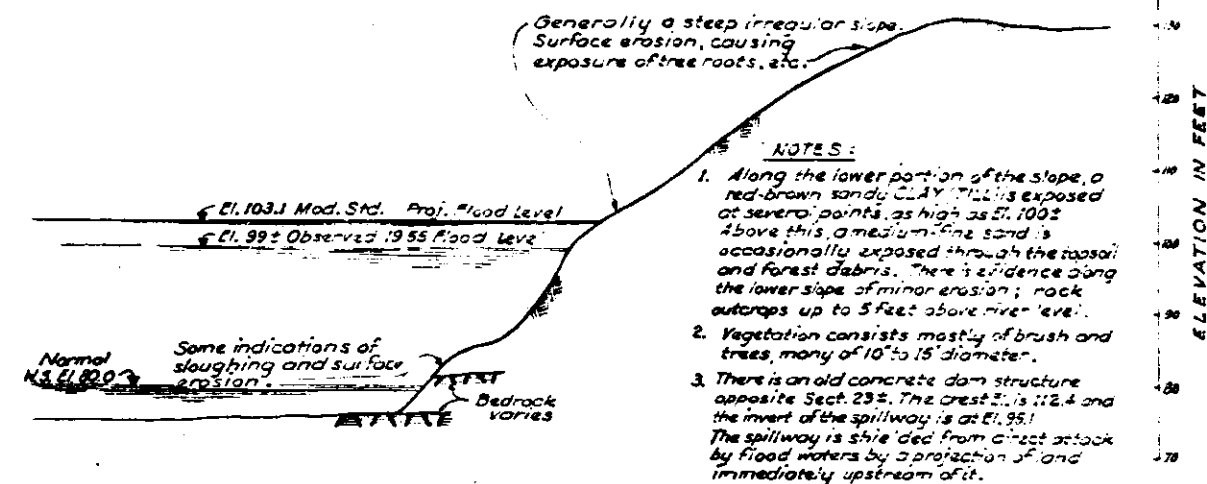
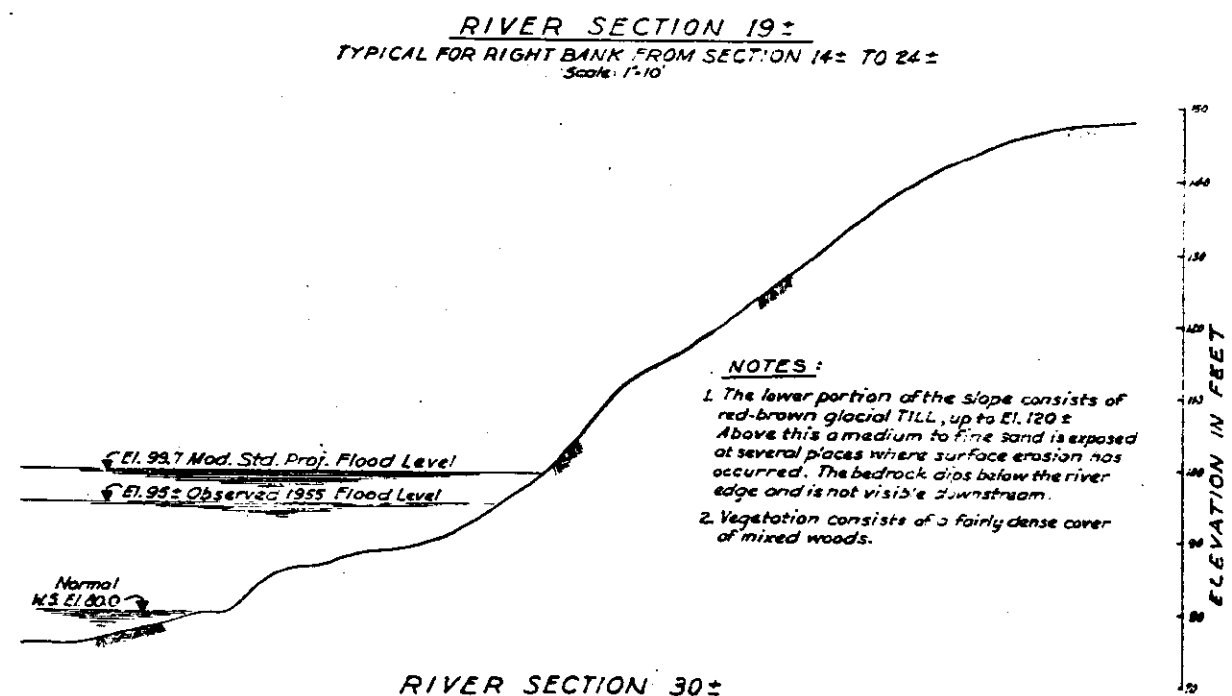
On Plate 3 are shown four typical cross-sections along the right bank which are considered to be representative of existing conditions, based on a reconnaissance of the entire area. The sections were selected at specific locations, with the appropriate design flood water elevations shown for those locations. There is usually a gradual transition in profile between the sections shown.

In general, the height of slope is from 50 to 75 feet above the river bottom, increasing in height in a downstream direction to approximately Section 30. The slope generally varies from 1 on 1.6 to 1 on 1.3 with a few somewhat steeper slopes near the river's edge, due apparently to river erosion. With the exception of the area in the vicinity of Section 24, the slopes are usually covered with a fairly dense growth of brush and trees. Specific comments are noted on each section in Plate 3.

At Section 24 <sup>±</sup>, there is a steep slope where, for a distance of some 240 feet along the river, the medium to fine sand stands at its natural angle of repose indicating that sloughing has occurred and is still continuing at a slow rate. Sand from the upper portion, some 70 feet above river

level, has sloughed down over the entire slope, with some buildup of materials at the toe of slope. As a result, very little vegetation has taken root in this area. The average angle of the slope is approximately 35 degrees above the horizontal. The material is a light brown medium to fine sand.

The Modified Standard Project Flood elevations as well as the observed levels of the 1955 flood are shown on each section, Plate 3. The ratio of the height of the design flood level to the total height of slope above river bottom decreases from approximately 0.5 at the upstream end to 0.3 at the lower end of the area under discussion.

To check on the stability of the existing slopes during flood stages, the right bank in the vicinity of Section 9 was selected for investigation. At this point, the design flood level extends nearly half way up the existing slope. It is assumed that soils of the entire slope are homogeneous and consist of medium to fine sand. Further downstream, the natural slopes are just as steep, and occasionally steeper,

Two trial failure circles were assumed as indicated on Section 9, Plate 3. The computed Factor of Safety for Trial No. 1 is 1.10, and for Trial No. 2 is 1.36, both for the "sudden drawdown" case. In addition, the condition of a submerged slope under design flood level was analyzed for Circle No. 2. The computed factor of safety is 1.54. No further analyses are considered necessary.

The proposed cross-section is shown at Section 40, Plate 3. A berm, fifteen feet in width, will be maintained at Elevation 81. Below this berm a 1 on 2 slope is carried to the channel floor. A 1 on 2-1/2 slope extends upward the full height of slope above the berm. At this section, the total height of slope is approximately 30 feet above the berm. The berm provides access along the river edge for maintenance and also a shelf for retention of materials which might slide down from above. The berm is pitched toward the river to facilitate runoff.

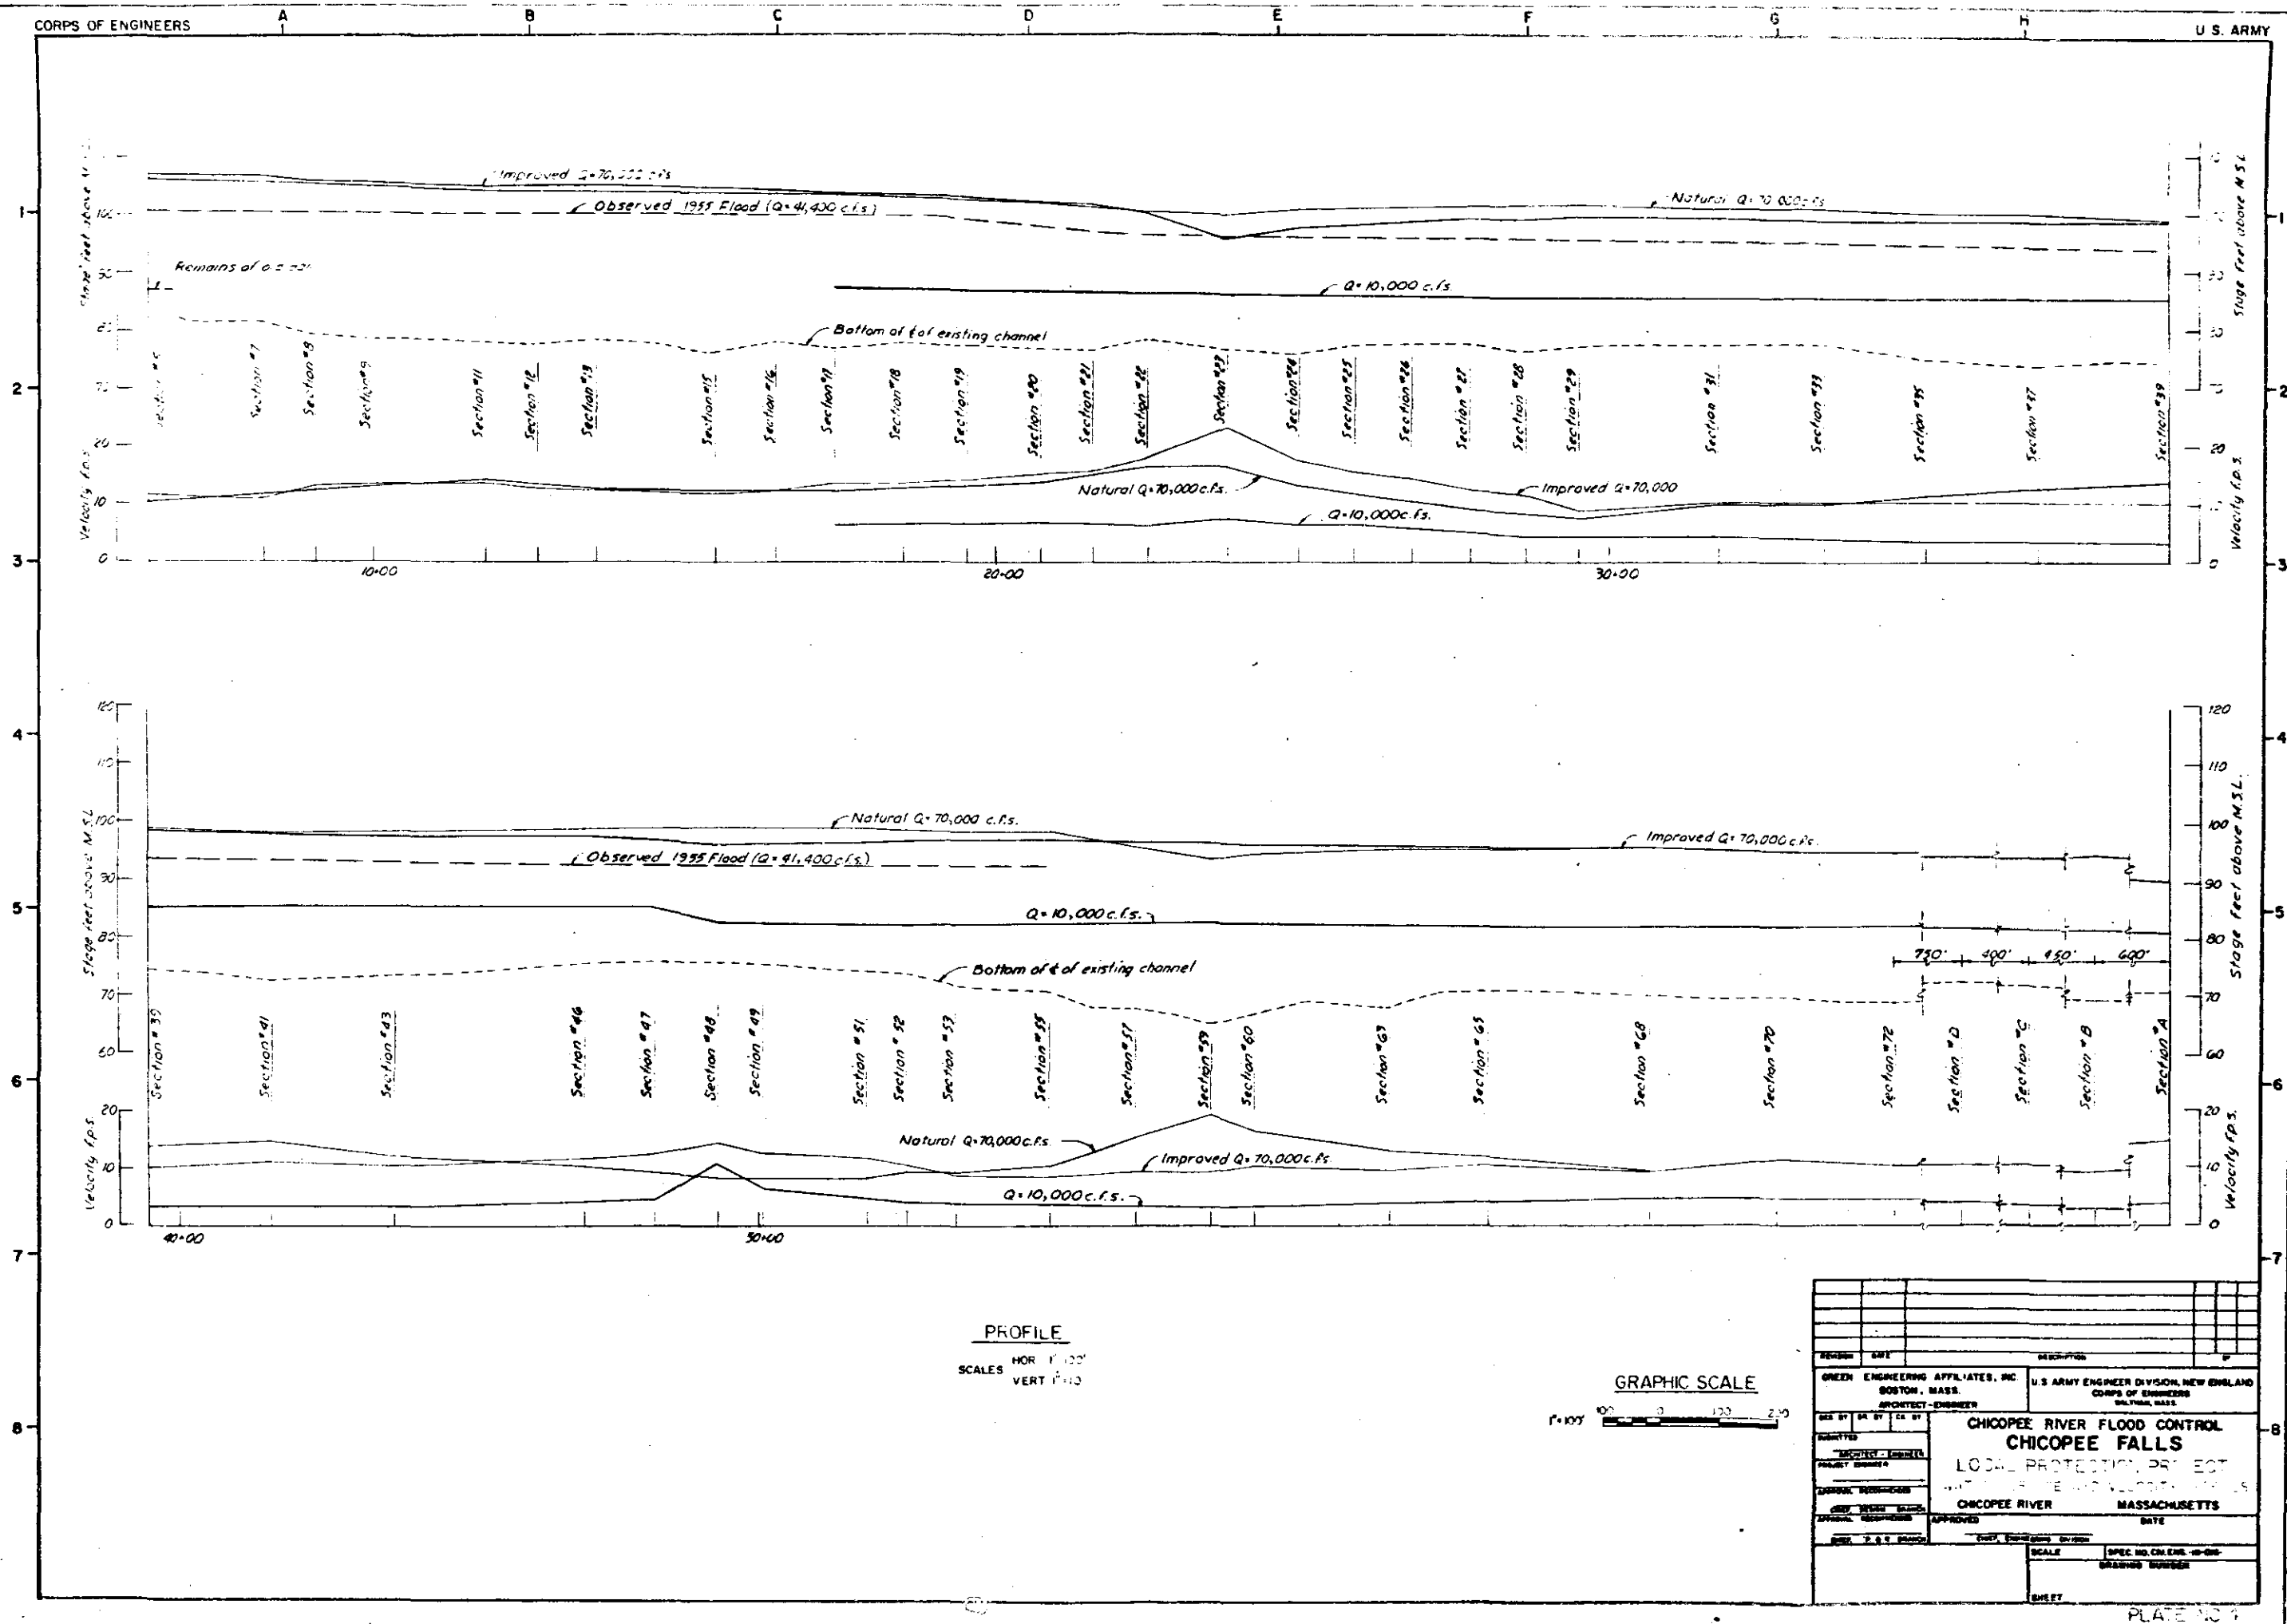
B. Hydraulics - Stage profiles are shown on Plate 4 for the 1955 flood (41,400 CFS) and for the Modified Standard Project Flood (70,000 CFS). The 1955 stages are from observed water levels; the Modified Standard Project Flood stages were determined by backwater analysis and velocity profiles for this flood are included on Plate 4.

As shown by the Plates, the river is generally in a rough and steep bed upstream of Section 17, becoming wider and assuming a more gradual bottom profile downstream. Roughness coefficients were fixed by reconnaissance at .045 upstream of Section 8, .040 from Section 8 to Section 16, and .035 downstream of Section 17, for the natural channel.

Average natural velocities in the main channel are estimated (at Modified Standard Project Flood) to vary between 9 and 17 feet per second. These are, in most reaches, comparable to velocities after construction of the Project, differing notably at the constrictions. Flow characteristics for moderate or smaller floods are expected to show only minor differences between natural and project velocities.

B. Hydraulics - Plate 4 presents stage and velocity profiles for the river with the Project completed, for the Modified Standard Project Flood (70,000 CFS) and for a moderate flood of 10-year frequency (10,000 CFS). Analysis was by backwater computations, using "n" for the natural channel as given above. For the improved channel, "n" was taken as .030. Allowance was made for bend losses.

Average velocities are generally 10 to 12 feet per second at design flood stage in the improved channel downstream of Section 33. This represents a decrease in velocity in the vicinity of Section 62 due to removal of the constriction there. A local peak velocity of 14 feet per second at the U. S. Rubber Company weir is expected when the weir is reconstructed, whether the project is constructed or not. In the area between Section 33 and the old tailrace, Section 29, velocities are about 10 fps. Further upstream, the velocities increase progressively to a peak of about 23 fps at Section 23 and then are reduced progressively around the bend to about 12 fps at Section 16. Further upstream, average velocities generally vary between 11 and 14 fps, primarily dependent upon the degree of channel constriction.

The average high velocity of 23 fps at Section 23 is due to a condition of critical flow estimated to be in this area due to the constriction of the channel. Analysis has

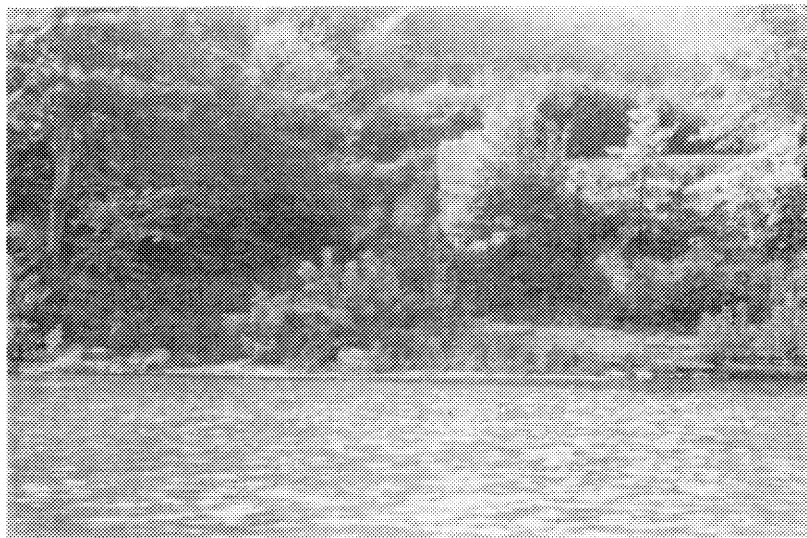
PHOTO #4

As for the open area near Section 24, it is expected that surficial sliding of the sand will continue as a result

of wind erosion, surface runoff, freezing, thawing, etc. The slope should not become much steeper inasmuch as the sand has reached its normal angle of repose. Some losses of material can be expected along the toe of slope due to erosive action of the river during flood conditions, together with possible minor losses due to rapid drawdown. Again, there is no known overall stability problem which would result in any major blockage to the river. Minor losses at the toe due to materials carried downstream would be quickly replaced by material sliding down the surface from above.
